# Allied Engineering

**St. Louis Church  
Structure, Front Façade, and Slate Roof Evaluation  
Auburn, ME**

September 15, 2021

**AEI Project: 21064**

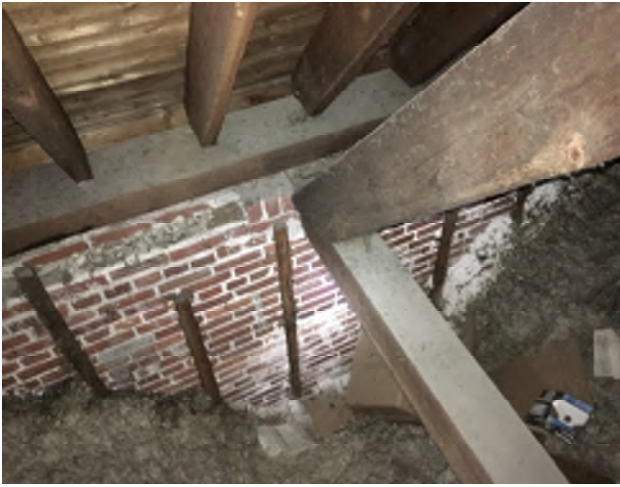
ROOF TRUSS BEARING AT PERIMETER  
BRICK WALL

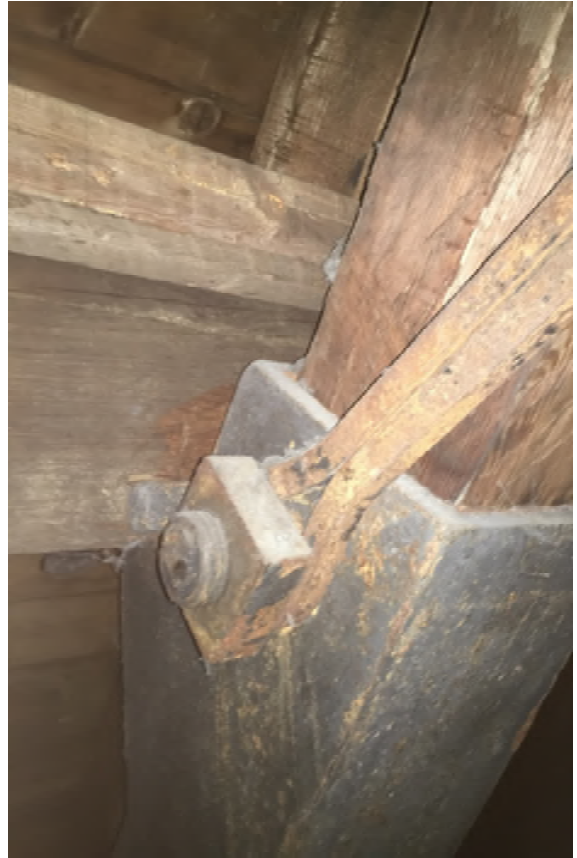
DETAIL A MAIN ROOF TRUSS

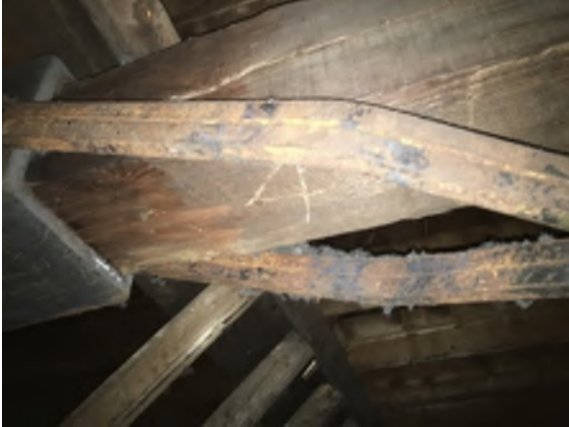
STEEL RODS MAIN ROOF TRUSS  
NEAR DETAIL A

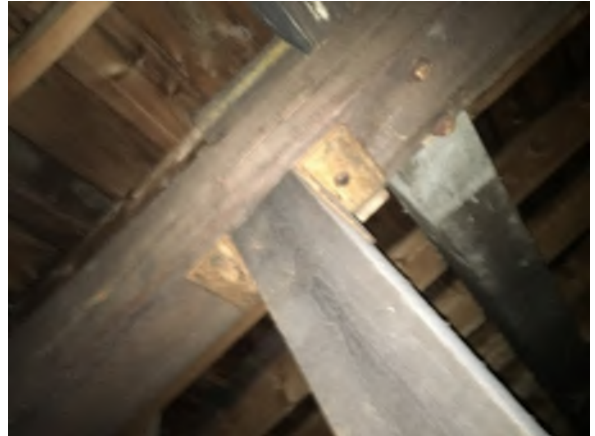
DETAIL B MAIN ROOF TRUSS

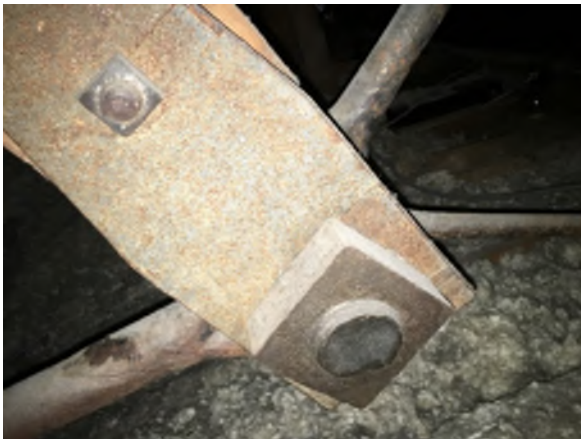
DETAIL C MAIN ROOF TRUSS

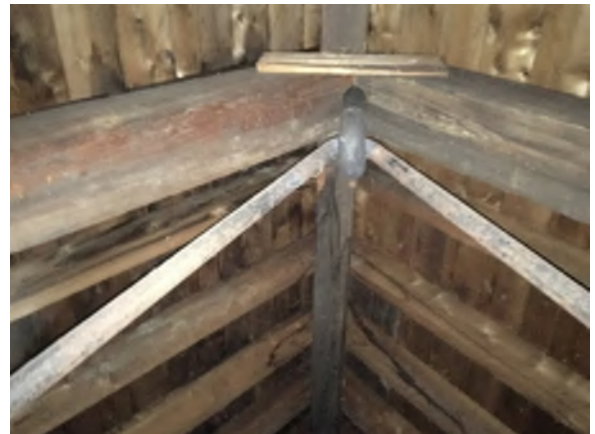
DETAIL D MAIN ROOF TRUSS

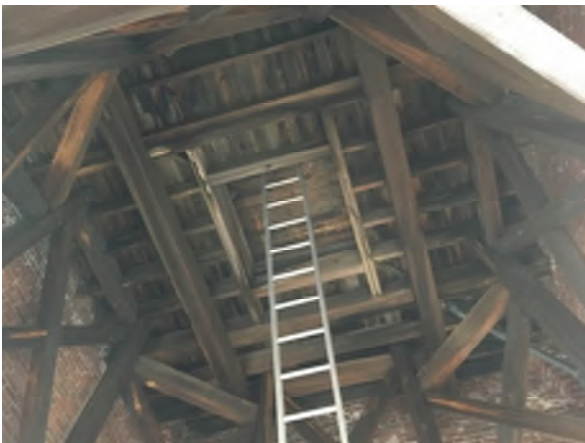
The flat framing for the roof of the Bell Tower consists of wood board sheathing supported by timber rafters supported by perimeter brick masonry walls and interior timber beams bearing on the perimeter brick masonry walls. The wood roof framing elements appear to be in good condition, free from any signs of significant moisture infiltration/rot, or other signs of distress or overloading. The floor framing for the Bell Tower consists of wood board sheathing supported by timber joists supported by perimeter brick masonry walls and two interior timber beams bearing on the perimeter brick masonry walls. The wood floor framing elements appear to be in good condition, free from any signs of significant moisture infiltration/rot, or other signs of distress or overloading. The bell tower has a heavy timber bracing system inboard of the perimeter brick masonry walls. The timber braces also appear to be in good condition.

BELL TOWER ROOF FRAMING

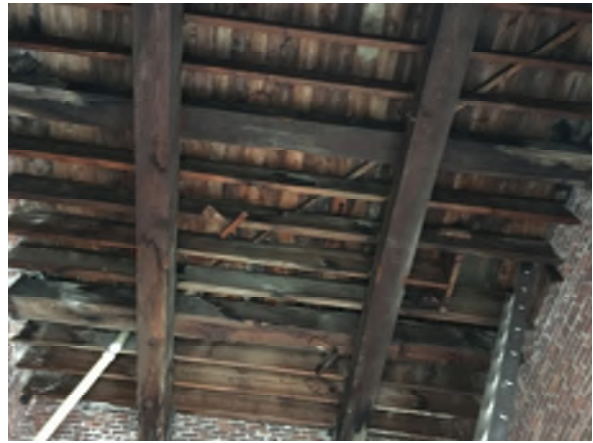
BELL TOWER FLOOR FRAMING

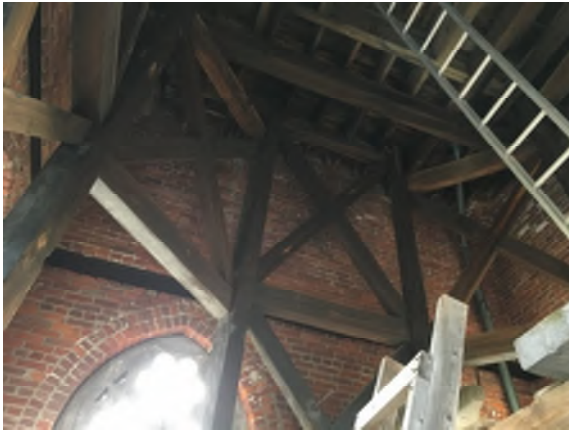
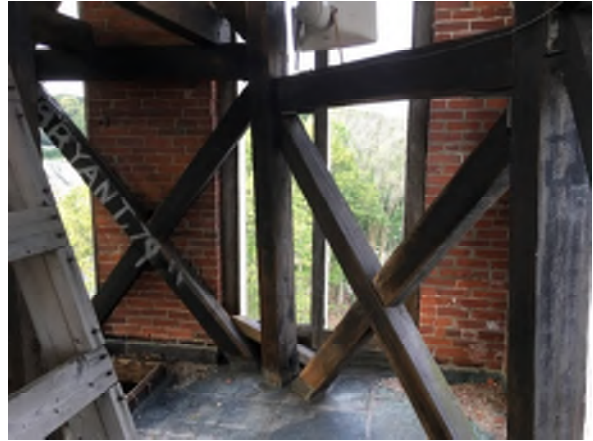
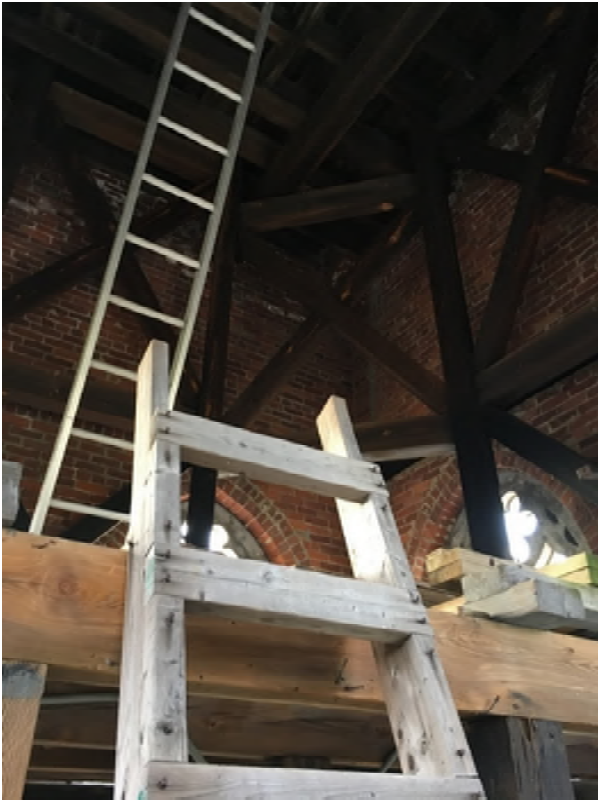
BELL TOWER TIMBER BRACING

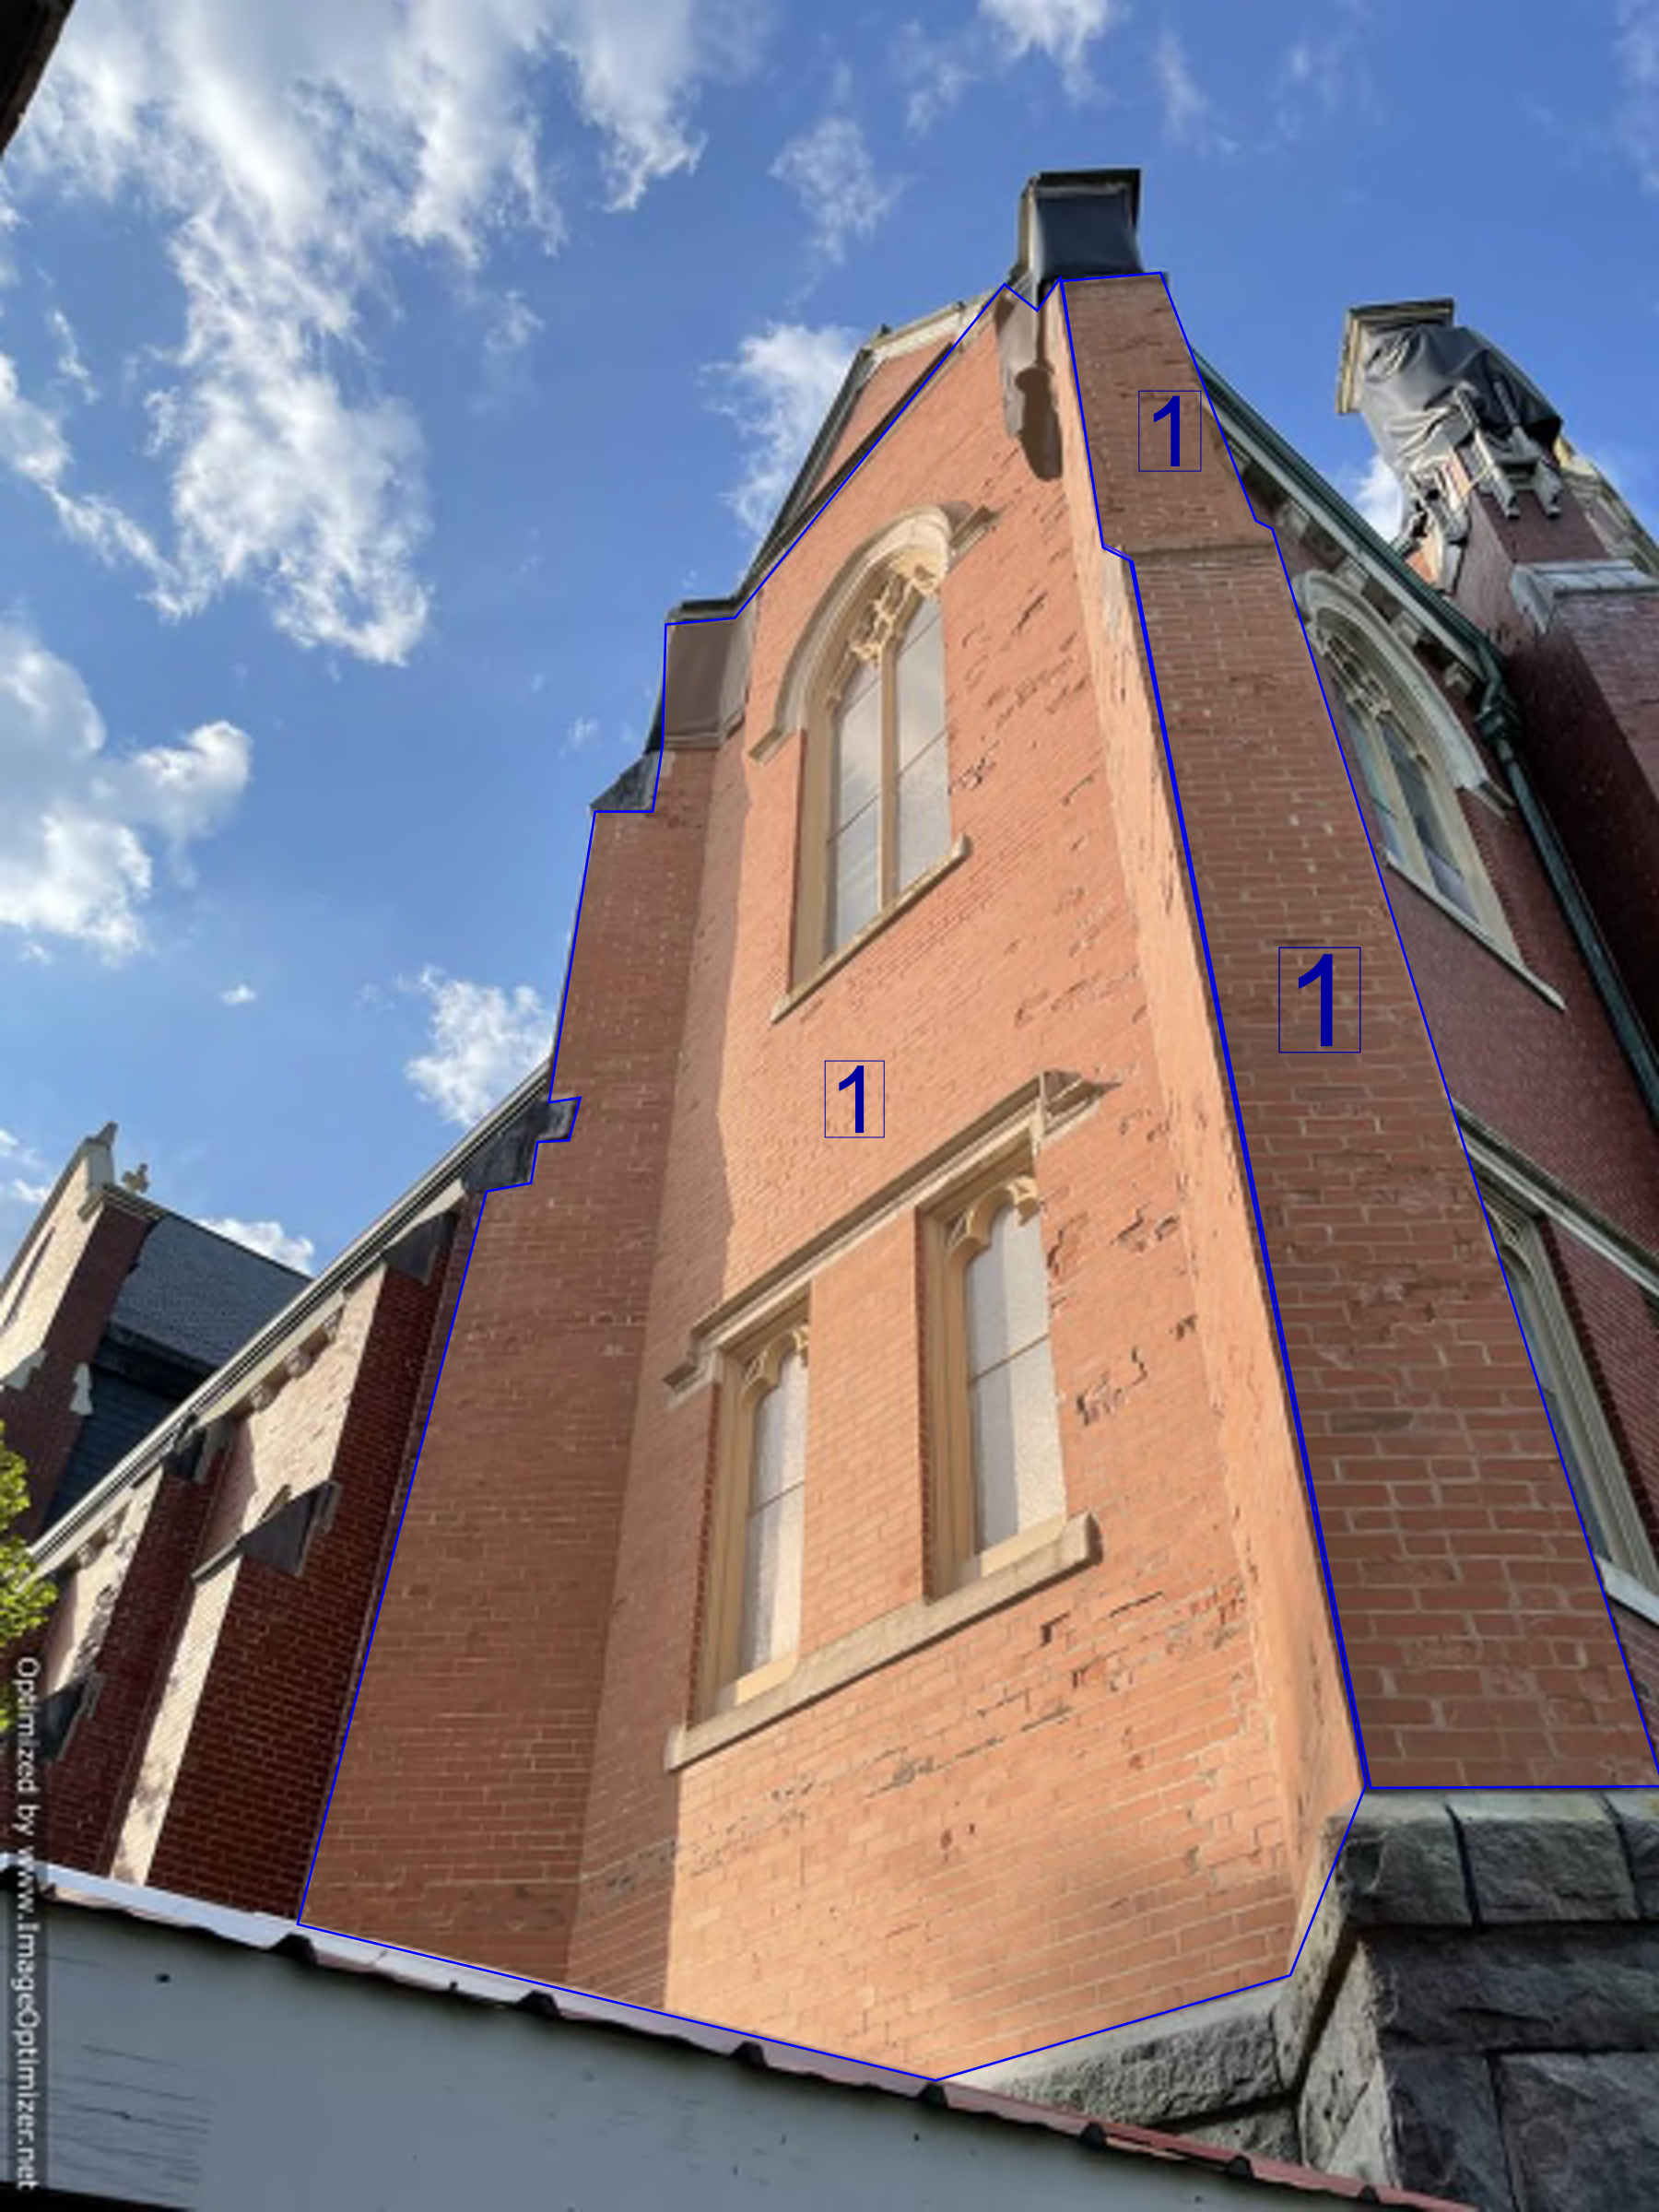
1. Brick Raking and Repointing with Spauled Brick Replacement – within these areas, the condition of the brick mortar joints are either cracked or missing due to water infiltration, freeze-thaw or degradation from water passing over the surfaces. All joints should be raked/repointed and those individual bricks where surfaces are spauled or deteriorated should be cut out and replaced.

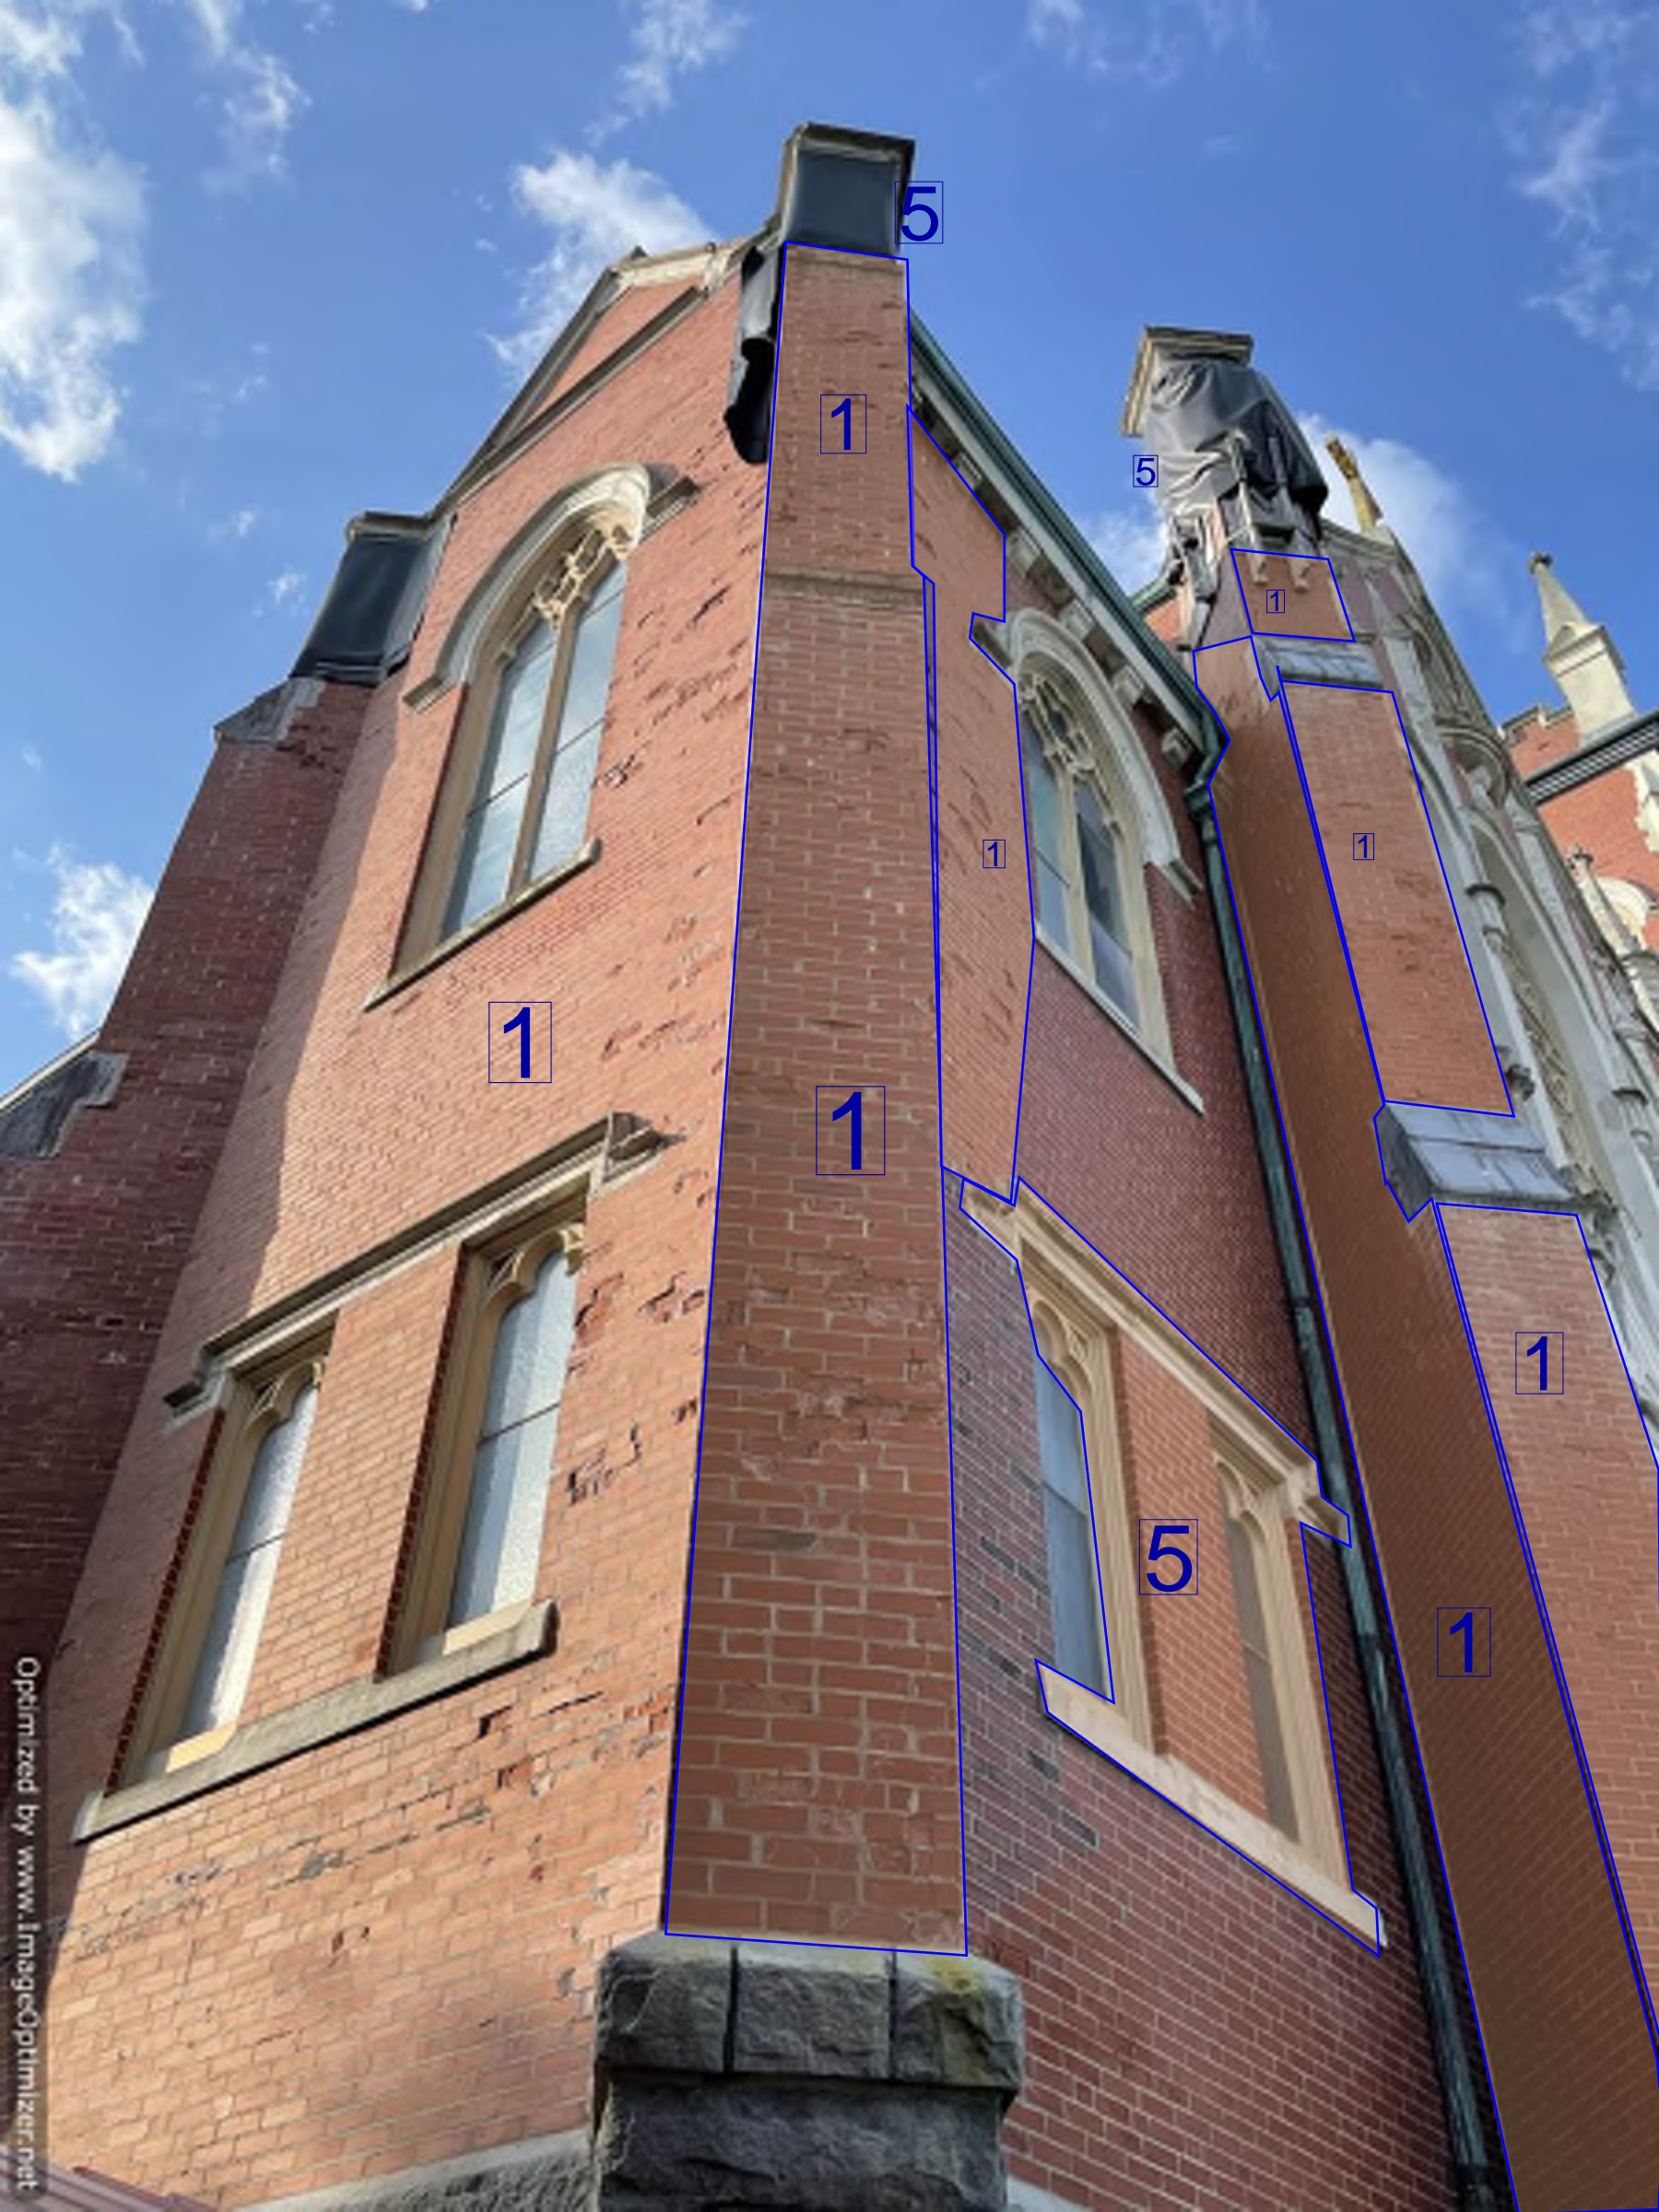
5. Individual Precast Repairs – There are various areas of precast degradation that require replacement with precast or covering with a similar lead coated copper cap as was done on the left side masonry column steps. These include eave decorative teeth, sloped precast caps, window decorative headers, and precast decorative sills. Each of the joints should be raked and regouted. When completed, the entire surface should receive a color matching concrete coating.

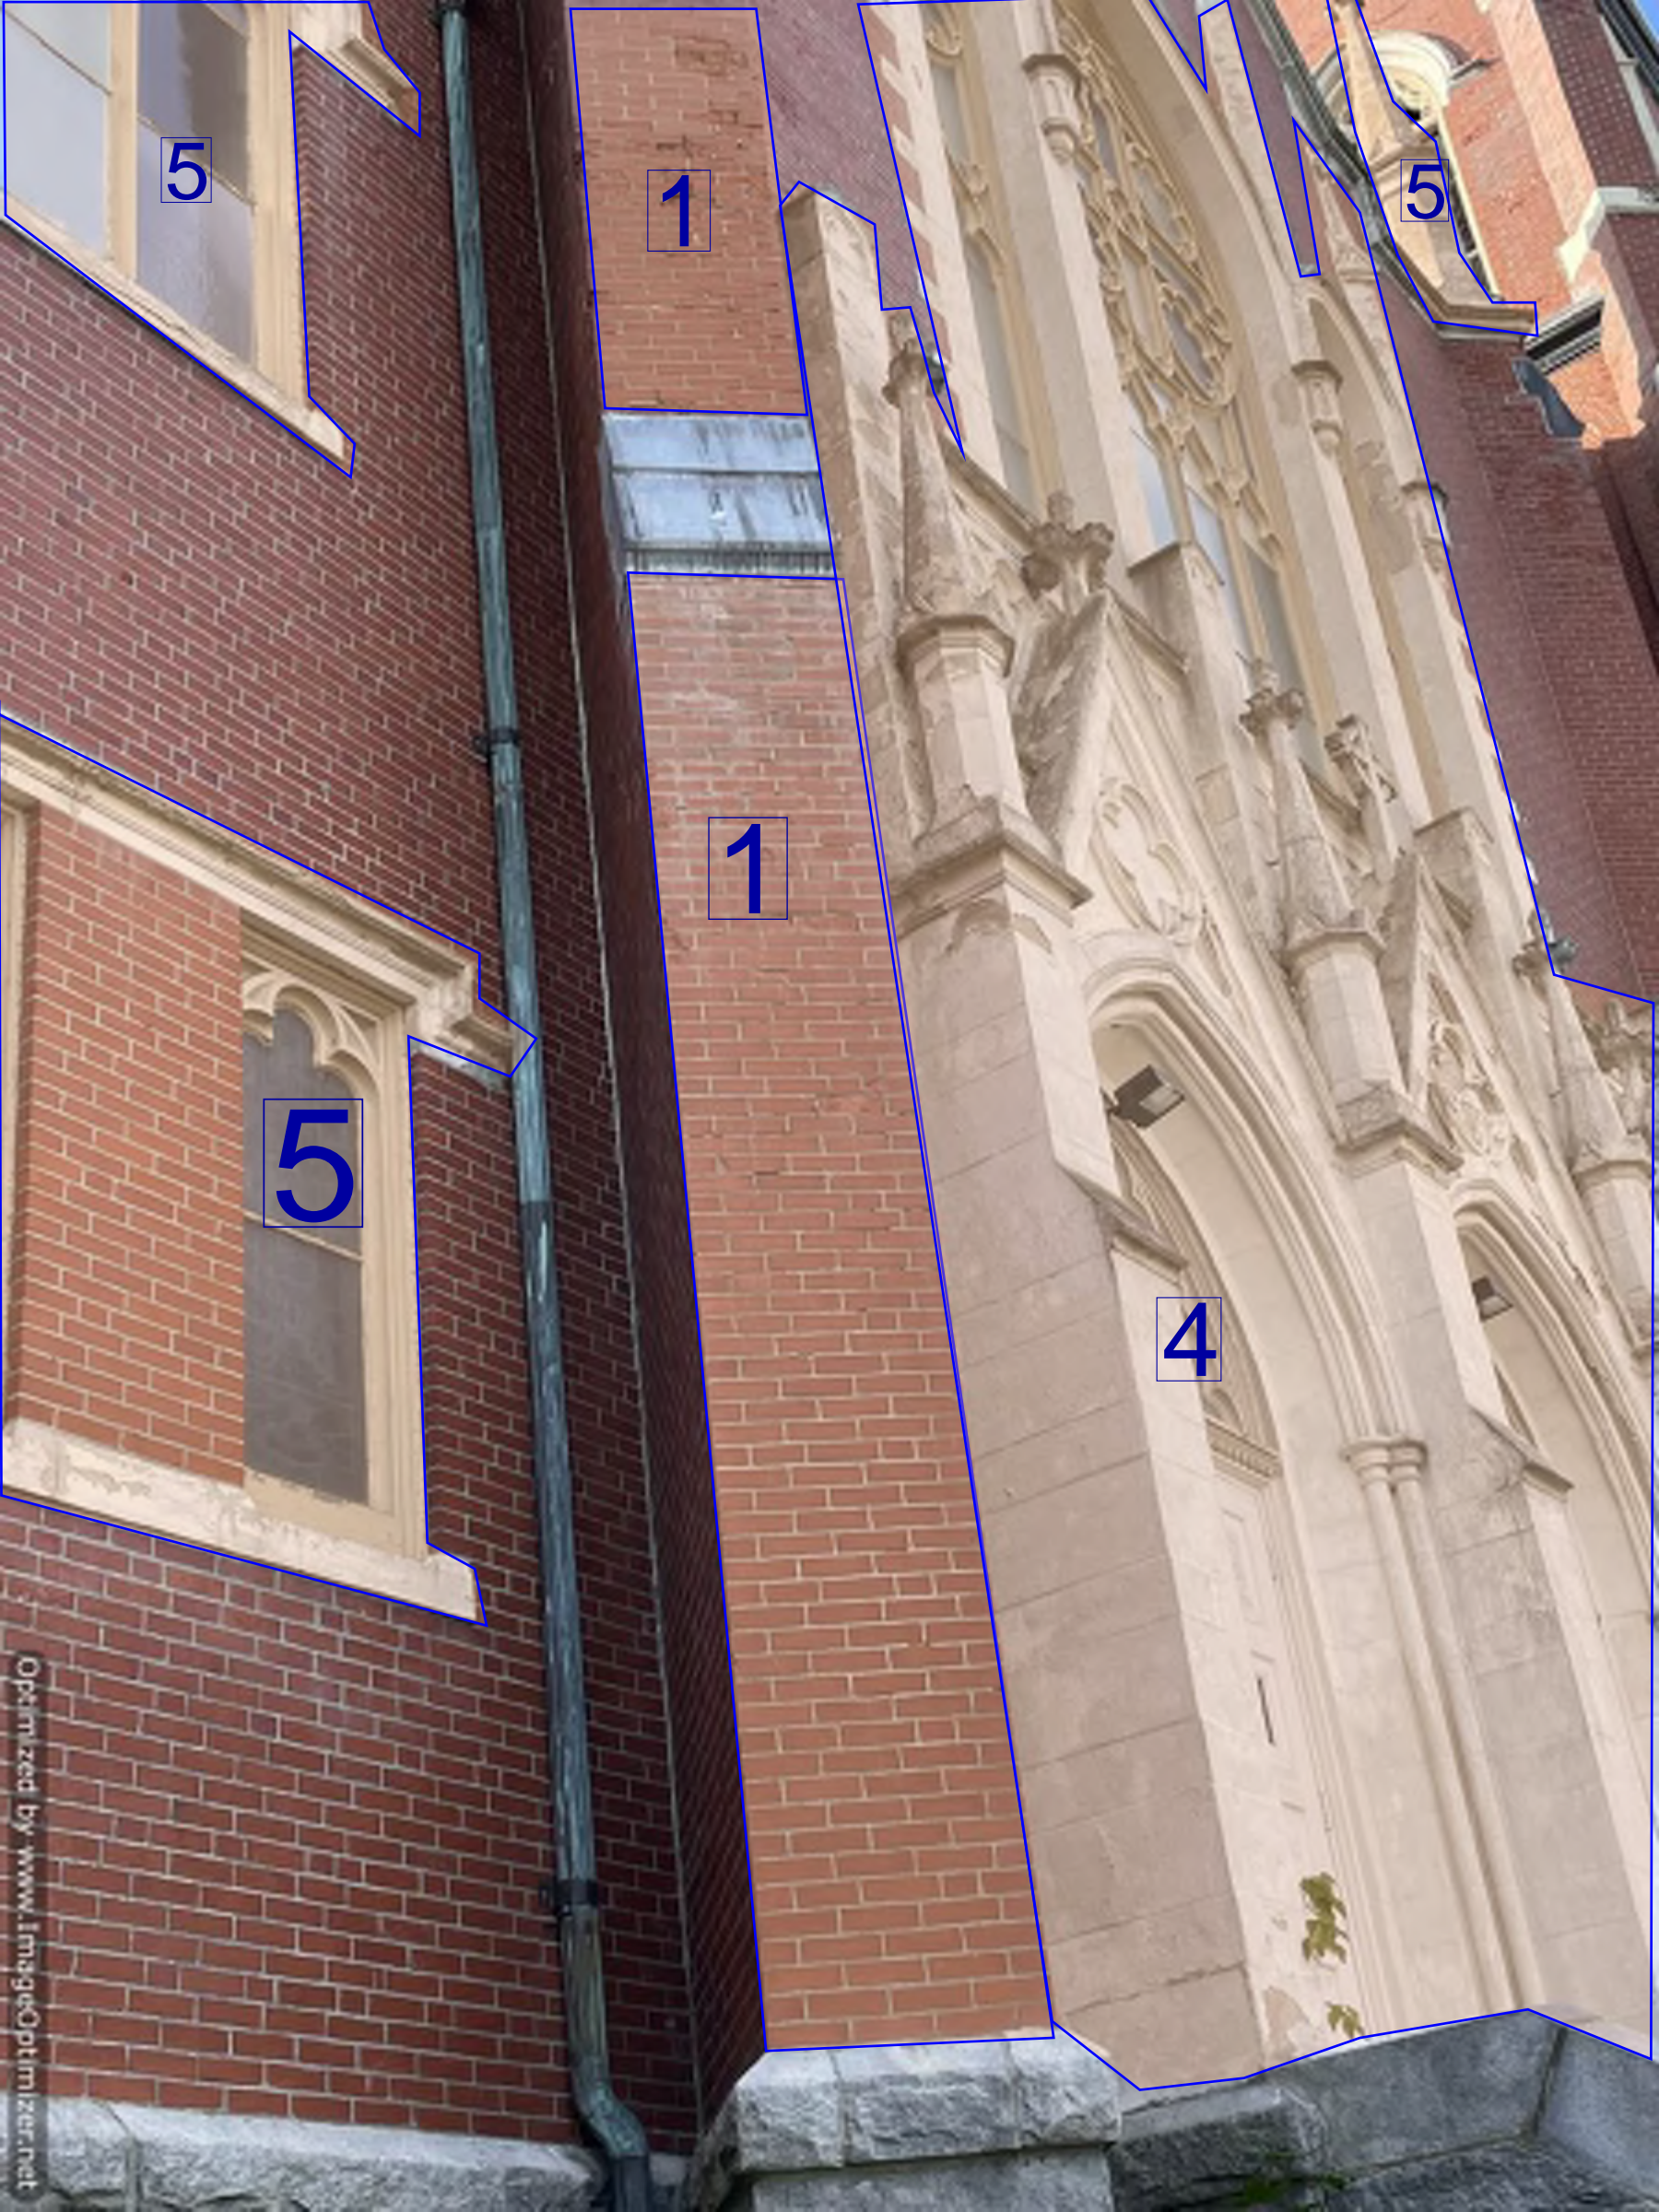
4. Decorative Concrete Façade Above Entry Doors – This precast concrete façade is compromised in many locations and much of the coating has delaminated. A more thorough examination is required of the condition of this system as a whole. For those pieces of the system that are severely damaged beyond in-place repair, surface molds can be developed to allow cast of replacement sections. Once the limits of work have been addressed, all precast joints should be raked and regouted. When completed, the entire surface should receive a color matching concrete coating.

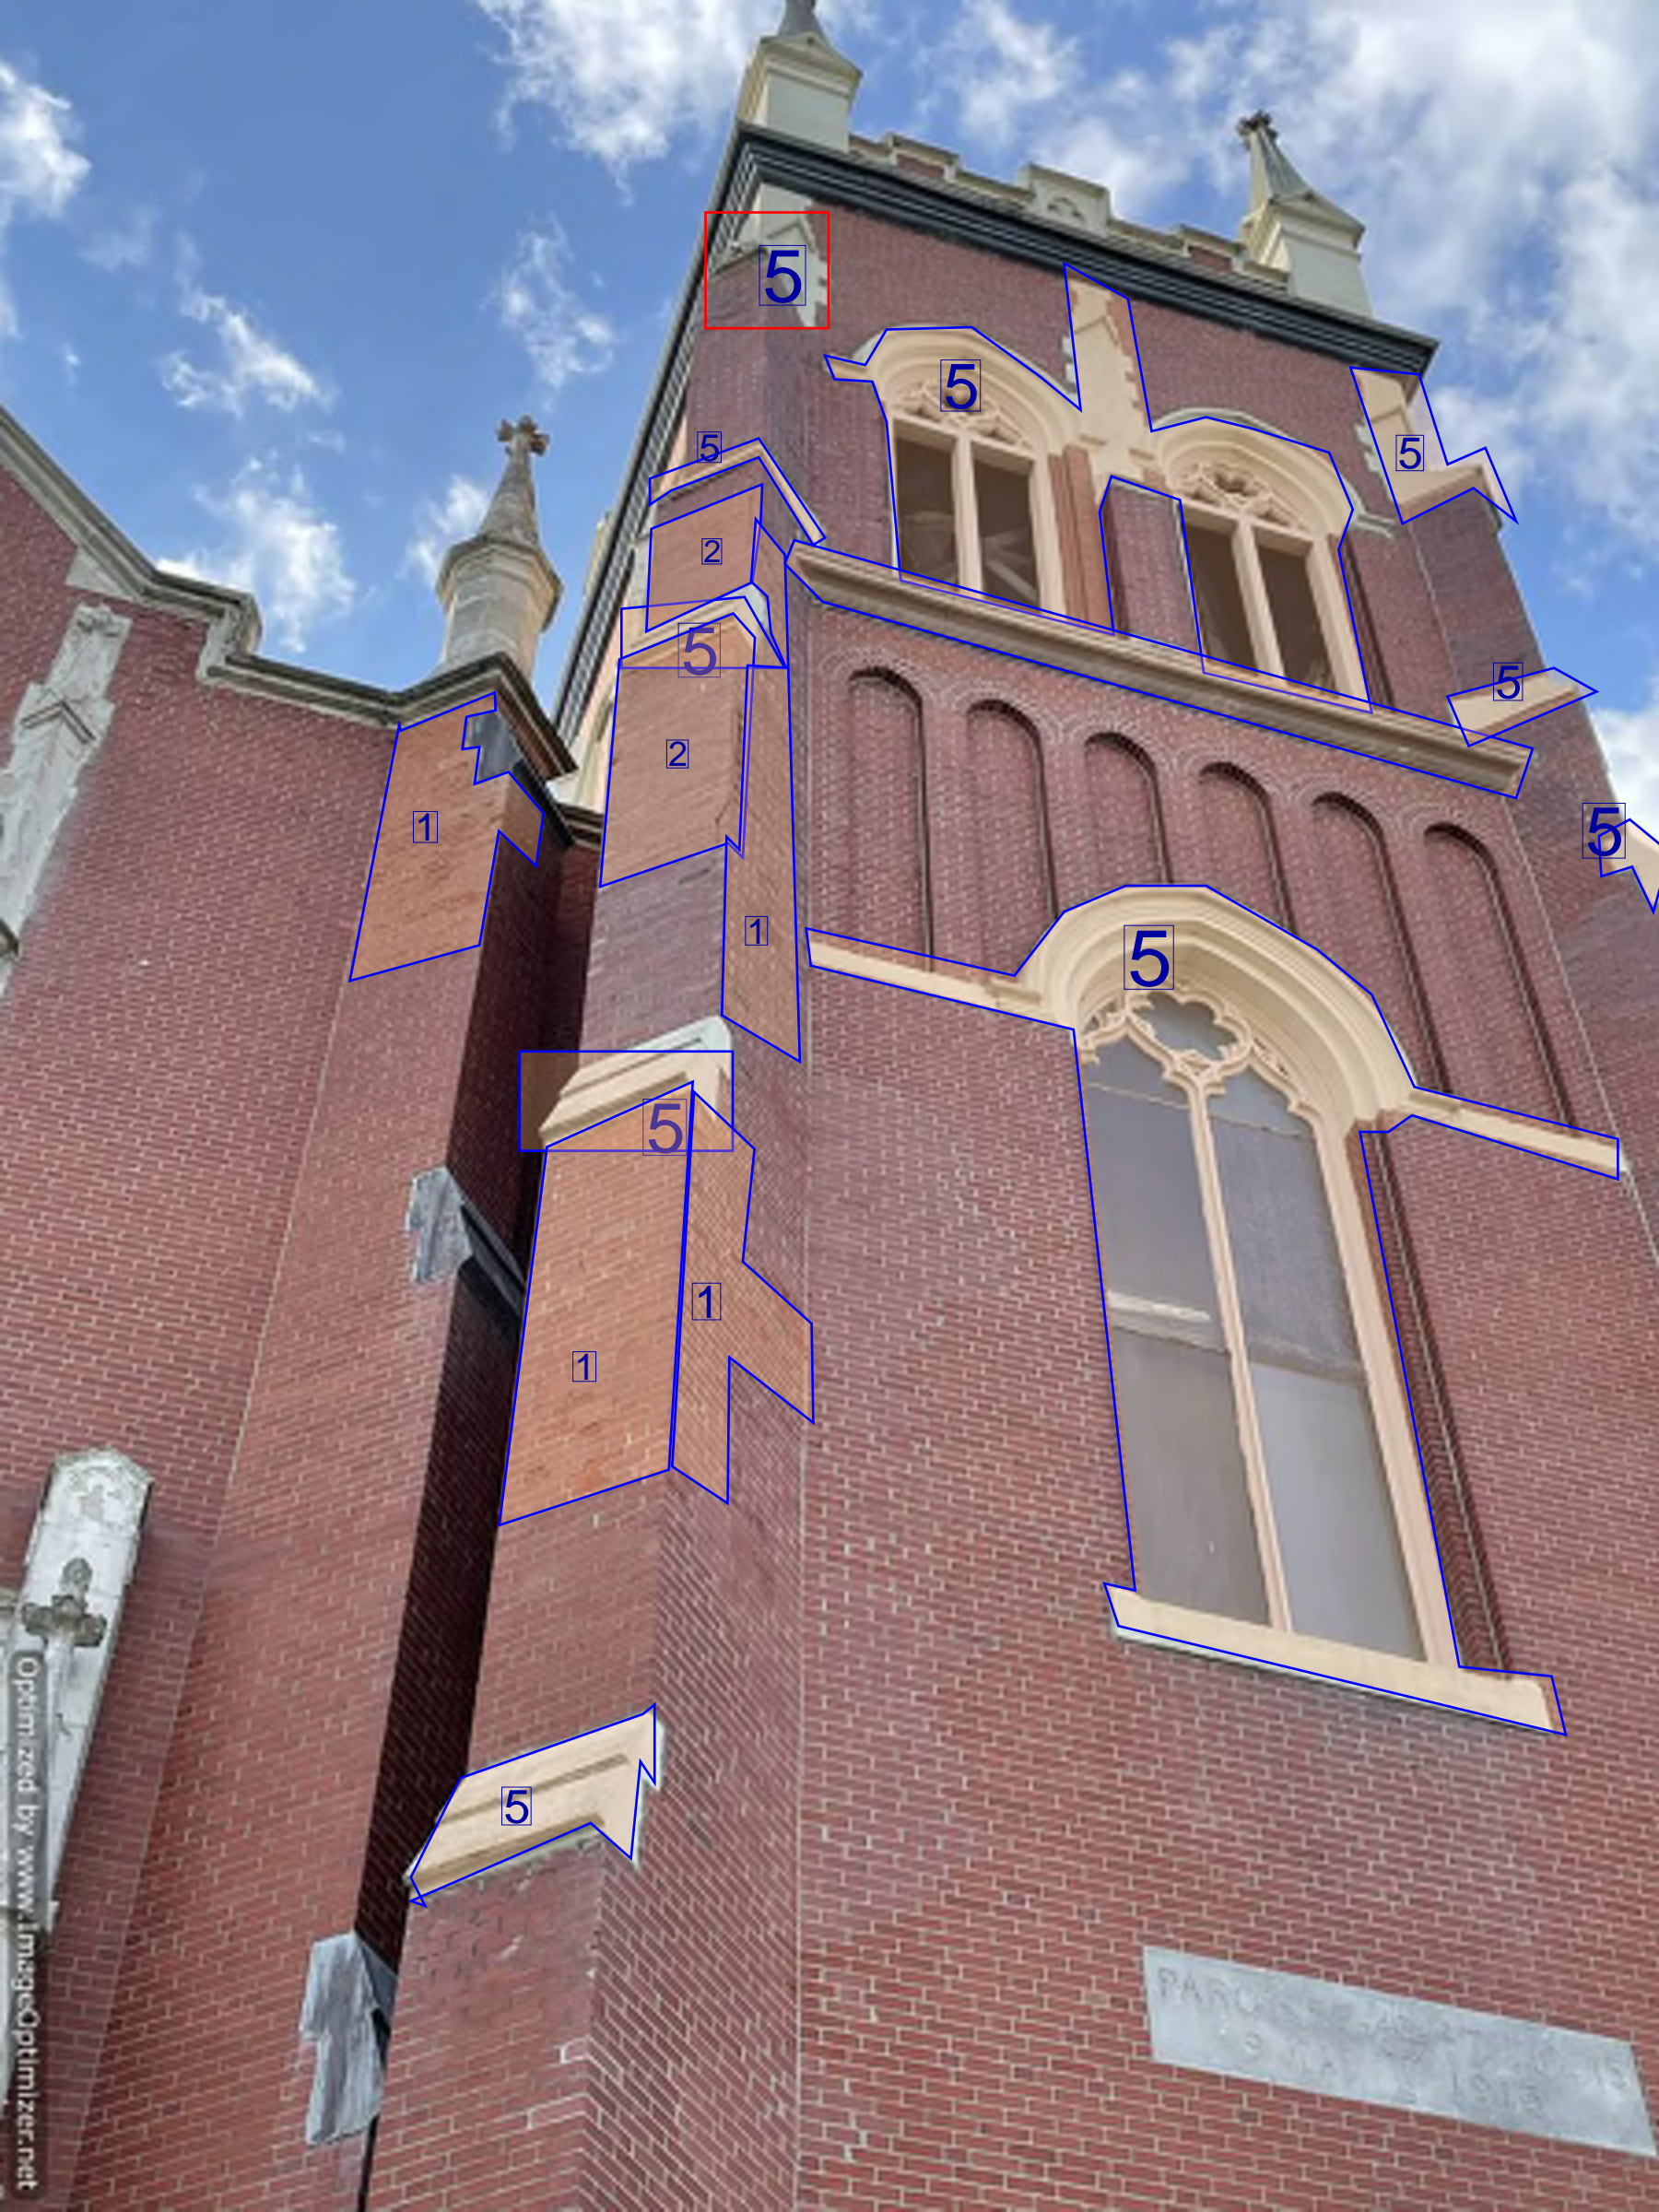
2. Brick Outer Wythe Separated from Interior Main Wythe - The outer brick wythe in these areas have separated away from the main wythe. These areas are susceptible to separation from the main wall system and should be addressed immediately. Removal of the outer wythe and removal/replacement of the precast step cap should be planned for.

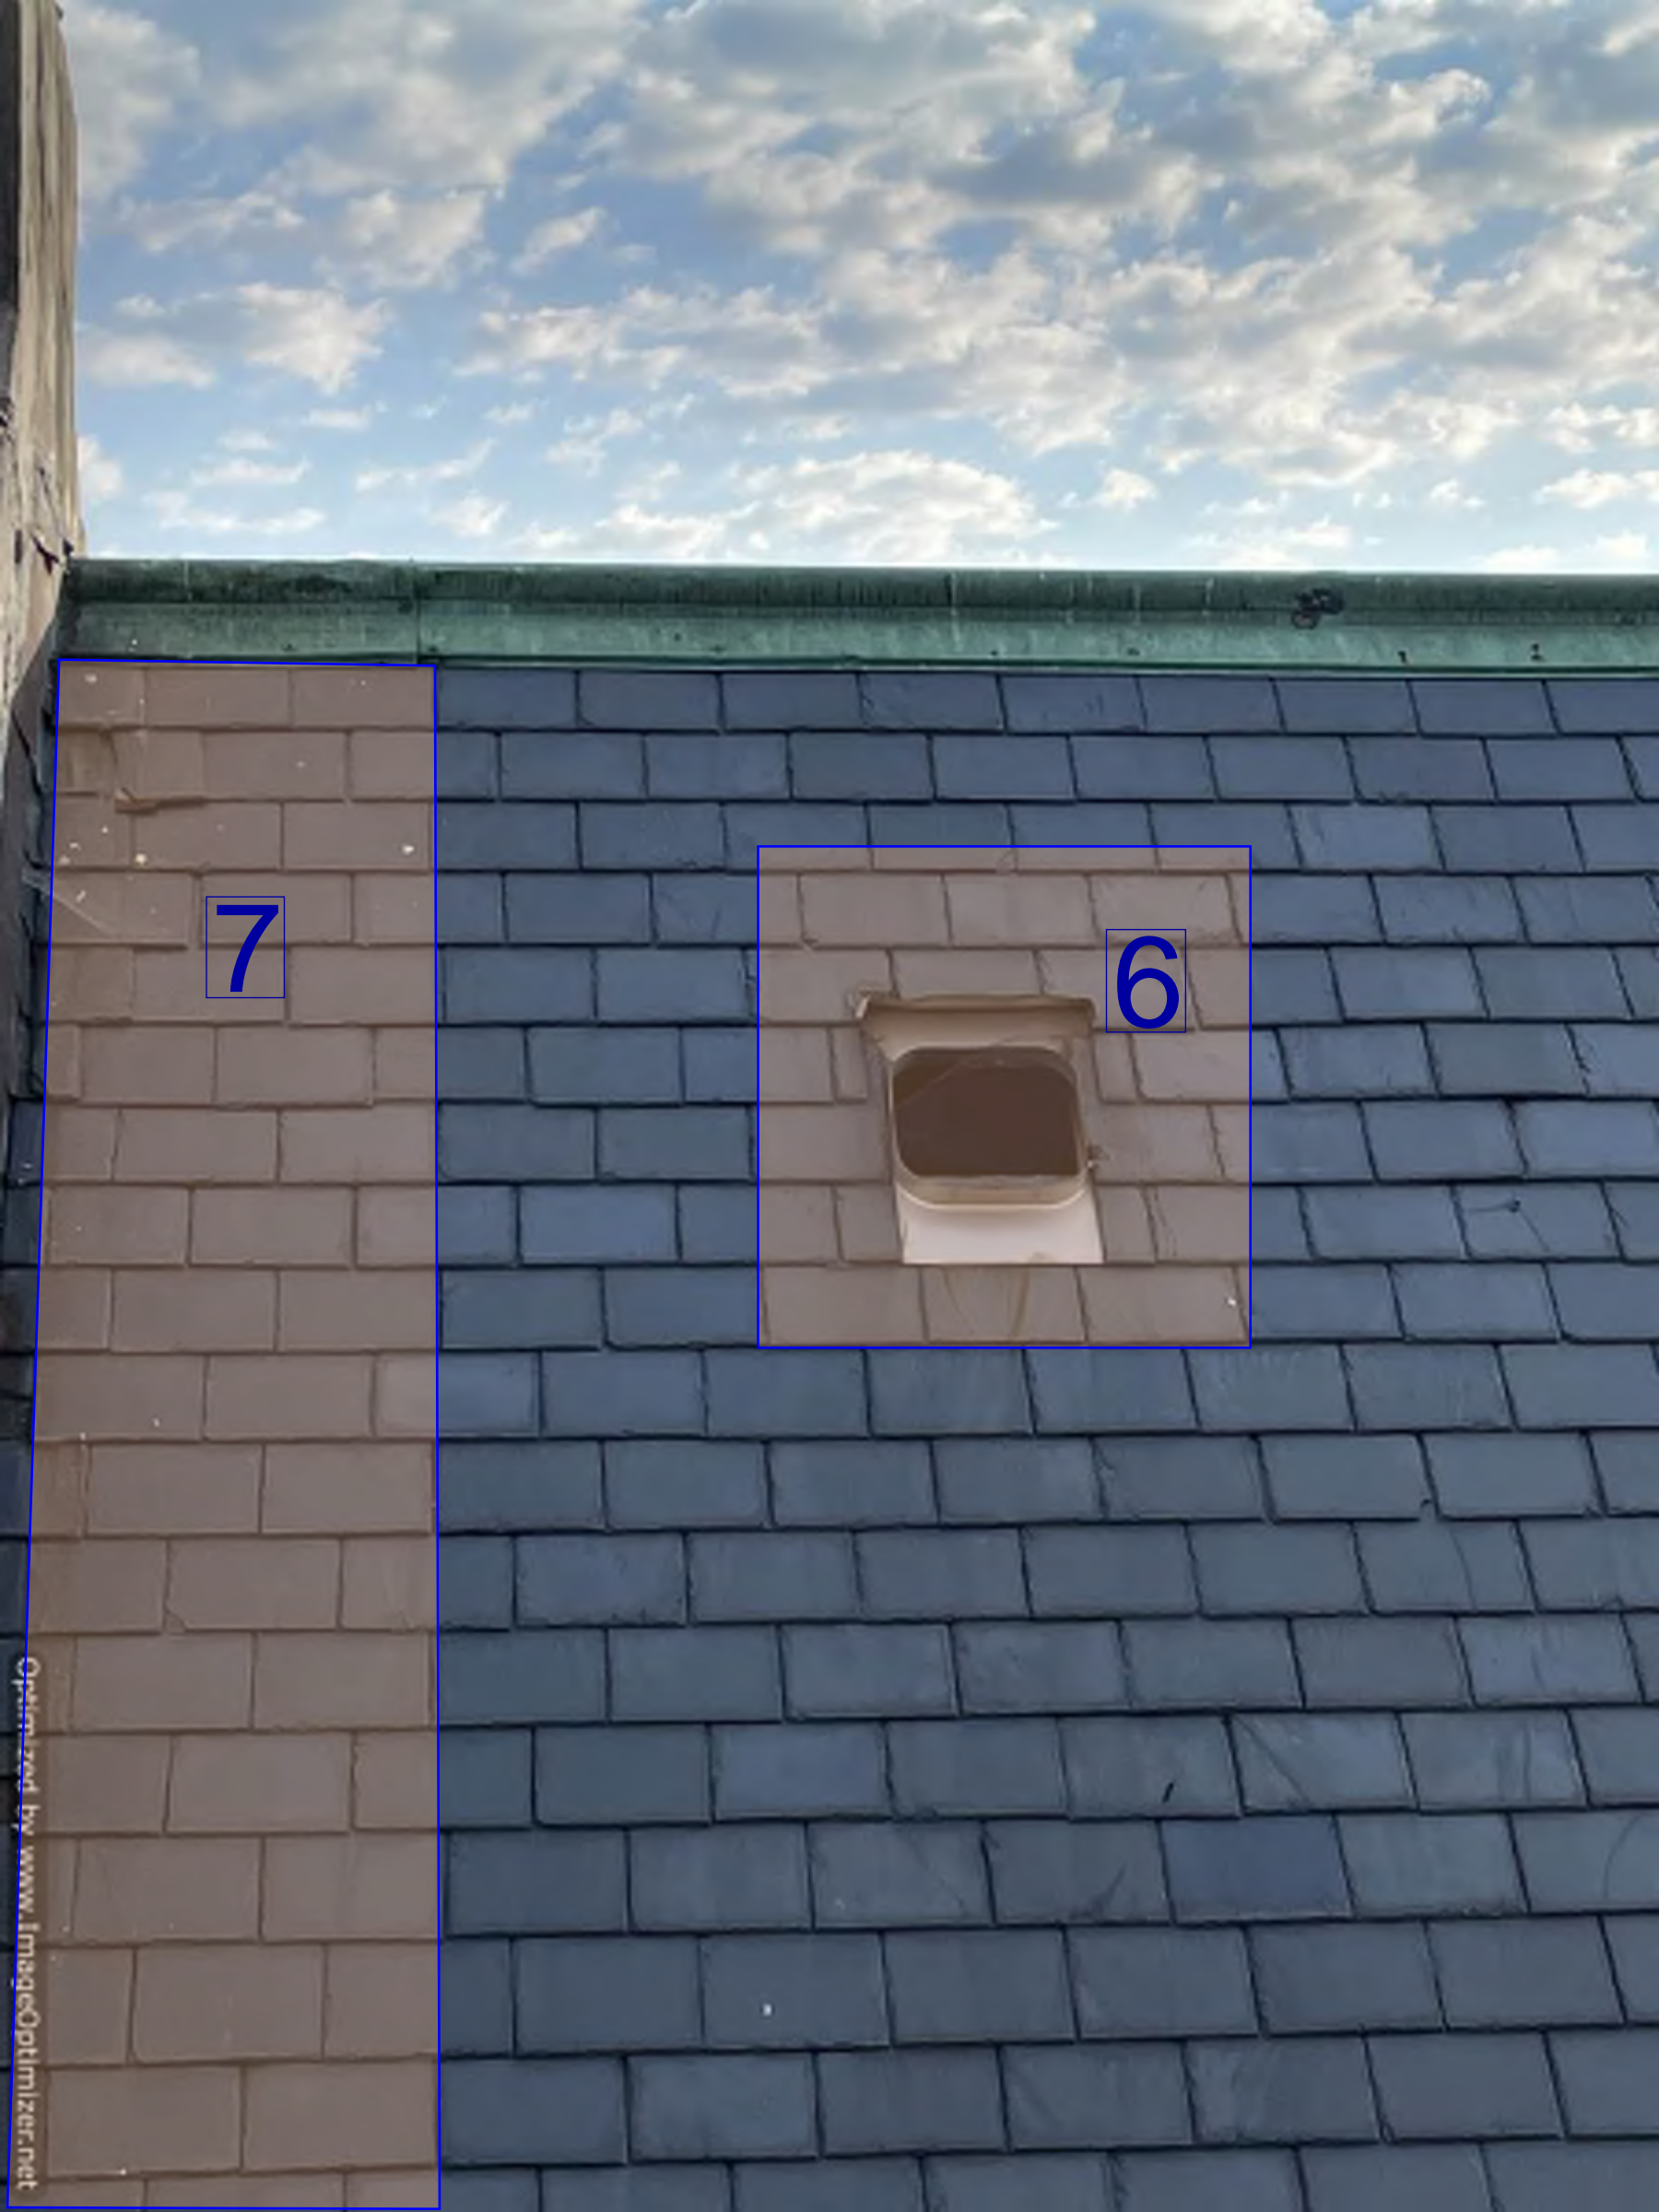
6. Missing attic gravity vent hood allows moisture and birds direct access into attic cavity. Replace with a covered unit of like size as a temporary repair until such time full renovations of the facility are undertaken. At that time a full evaluation and design of appropriate attic ventilation can be performed.
7. The parapet flashing of the roof slope at the side wall should be further investigated and repaired. A counter flashing system exists along the parapet wall that extends over the roof to wall copper step flashing. The step flashing is no longer flush and is pulled out away from

the parapet allowing direct access to the step flashing. The step flashing, in turn, appears to no longer be continuously flush at the wall either, so open voids to attic and the brick parapet wall exist. These systems should be returned to their design condition, replacing any torn or damaged flashing or counterflashing as required to achieve a properly flashed/counter flashed system. In order to apply new step flashing, approximately 12-16" of slate shingle will need to be removed to facilitate installation.
