# Allied Engineering

**St. Louis Church  
Structure, Front Façade, and Slate Roof Evaluation  
Auburn, ME**

September 15, 2021

**AEI Project: 21064**

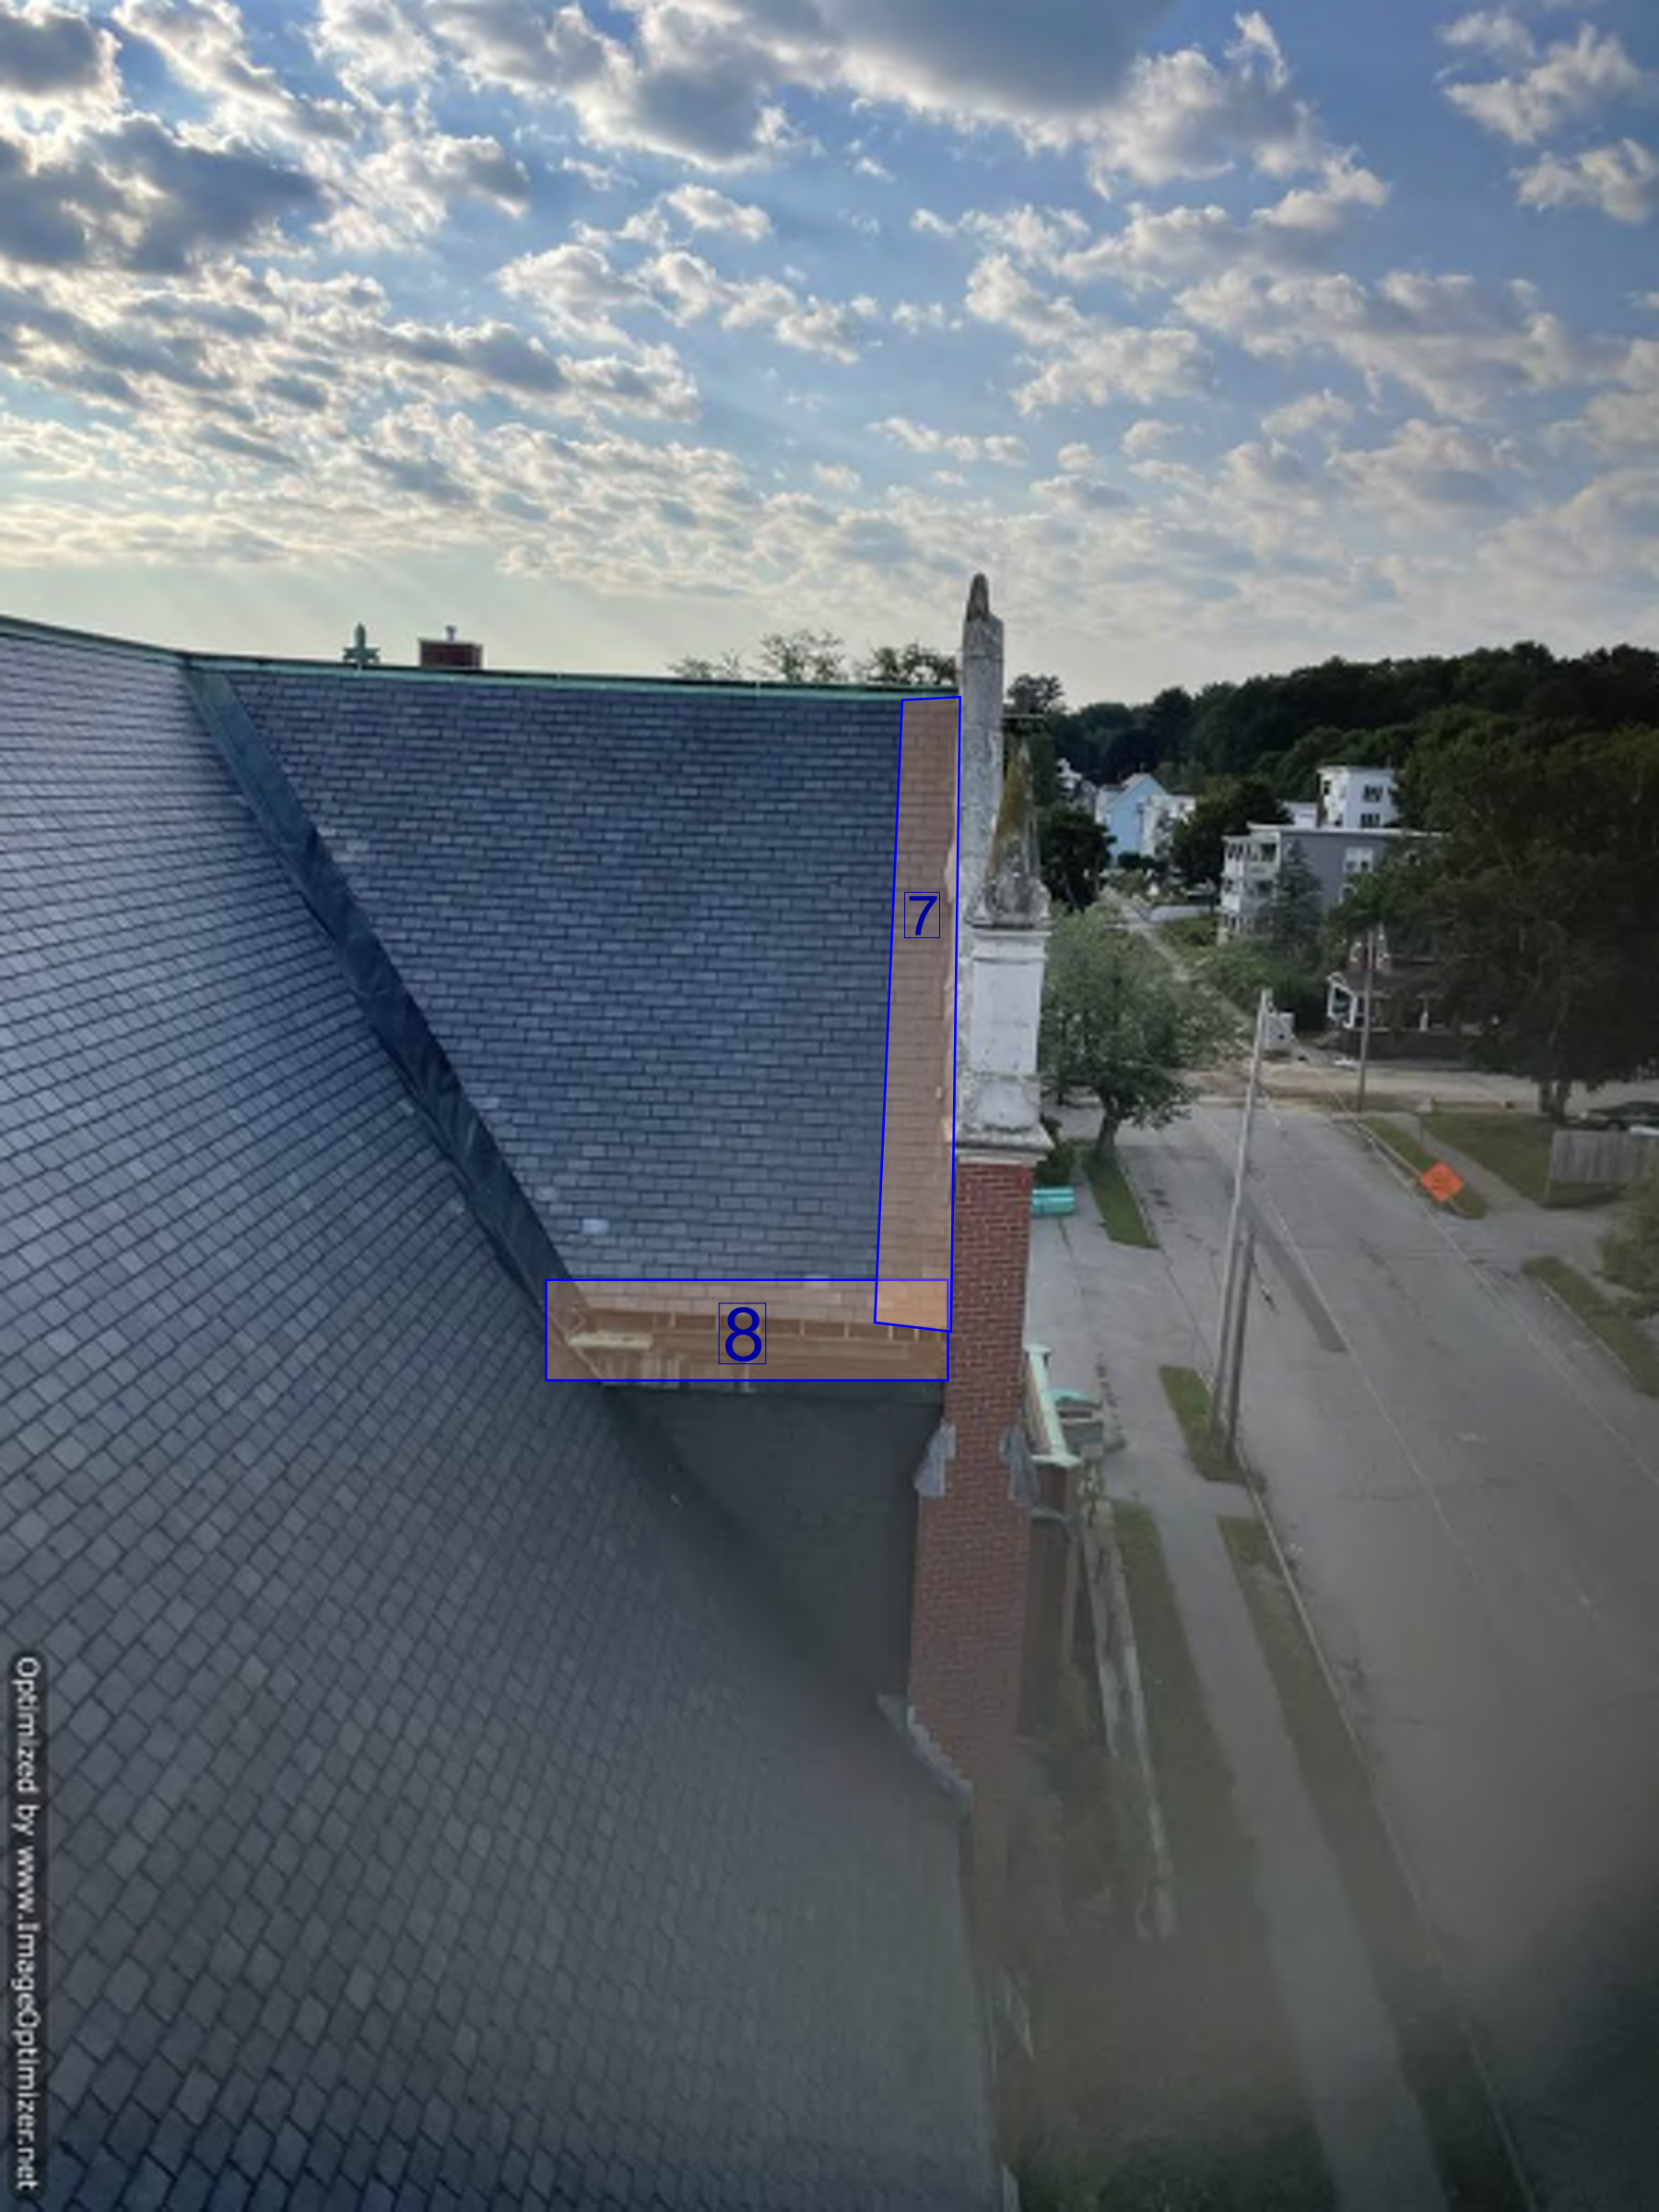
the parapet allowing direct access to the step flashing. The step flashing, in turn, appears to no longer be continuously flush at the wall either, so open voids to attic and the brick parapet wall exist. These systems should be returned to their design condition, replacing any torn or damaged flashing or counterflashing as required to achieve a properly flashed/counter flashed system. In order to apply new step flashing, approximately 12-16" of slate shingle will need to be removed to facilitate installation.

8. At the eave of each of the gable dormers above the main roof slope, there is a gutter system collecting the dormer roof runoff. However, there is no visible downspout system, which is curious as we are not sure of the following:
  - a. Whether the gutter was included to act more as a snow guard for falling snow between roof levels.
  - b. Where or how the accumulated water is directed during a storm event. This condition should be reviewed more closely to determine whether a short run of downspout to the gutter system provided at the main lower eave is required.

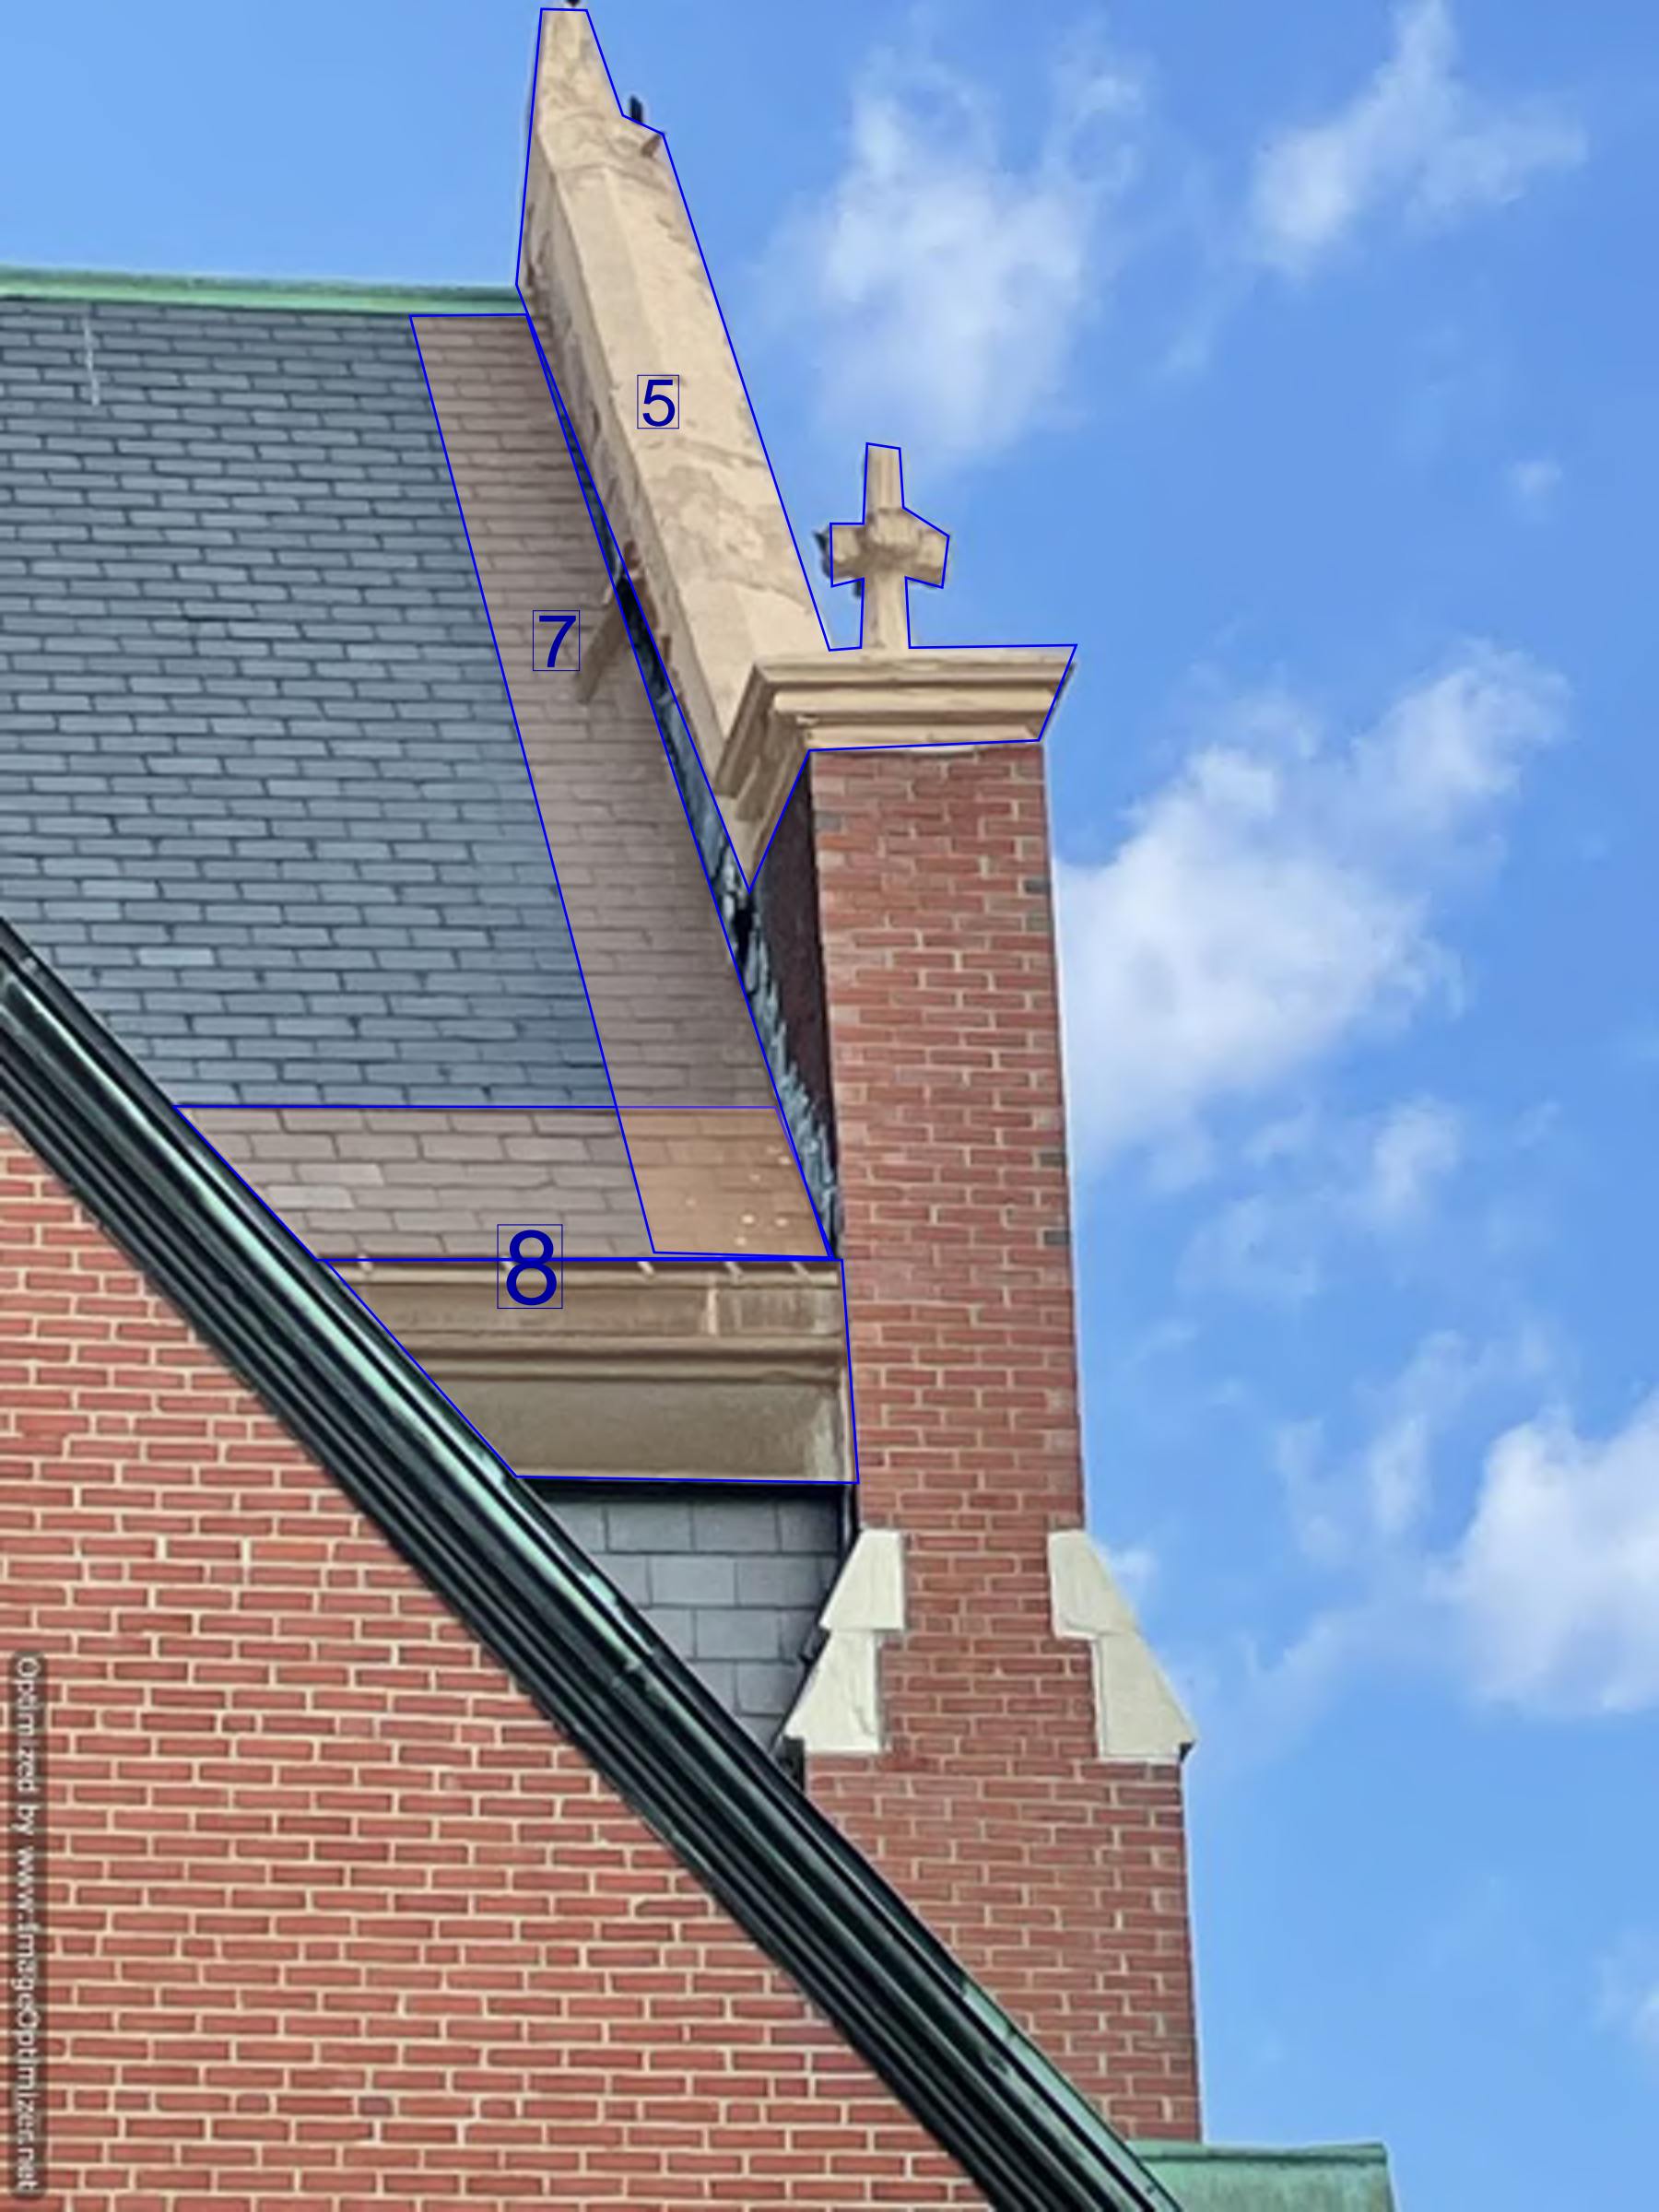
5. Individual Precast Repairs – There are various areas of precast degradation that require replacement with precast or covering with a similar lead coated copper cap as was done on the left side masonry column steps. These include eave decorative teeth, sloped precast caps, window decorative headers, and precast decorative sills. Each of the joints should be raked and regouted. When completed, the entire surface should receive a color matching concrete coating.
